EXPANDED SITE INSPECTION REPORT

**FORD ROAD LANDFILL
ELYRIA, OHIO**

U.S. EPA ID NO.: OHD 980 510 002

FINAL REPORT

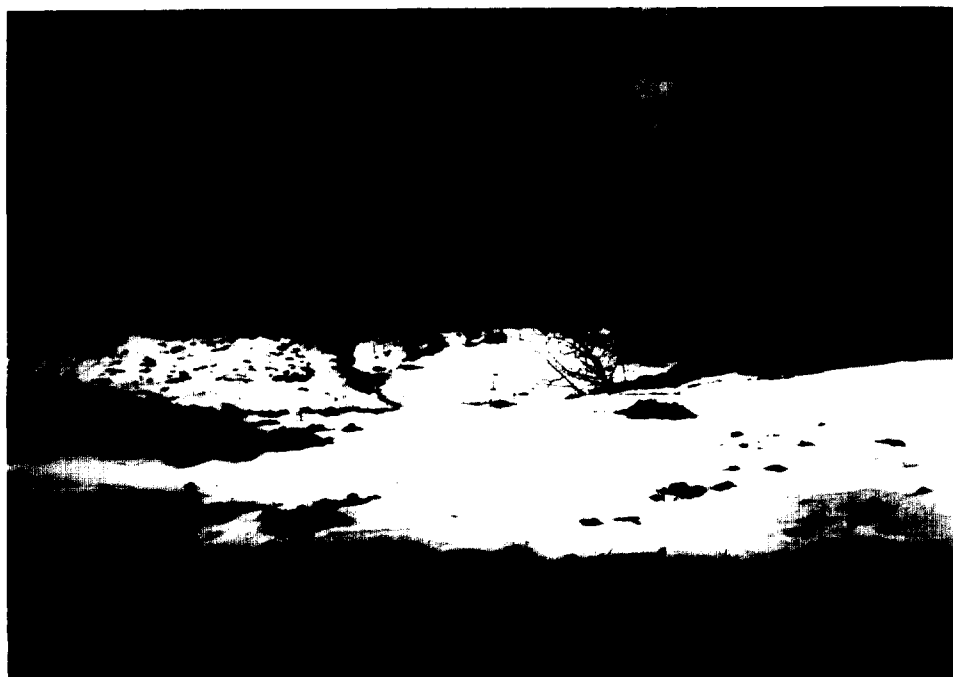
Photograph No.: 2

Description: Picture taken looking down cliff to the Black River. In the center of the picture a monitoring well is visible.

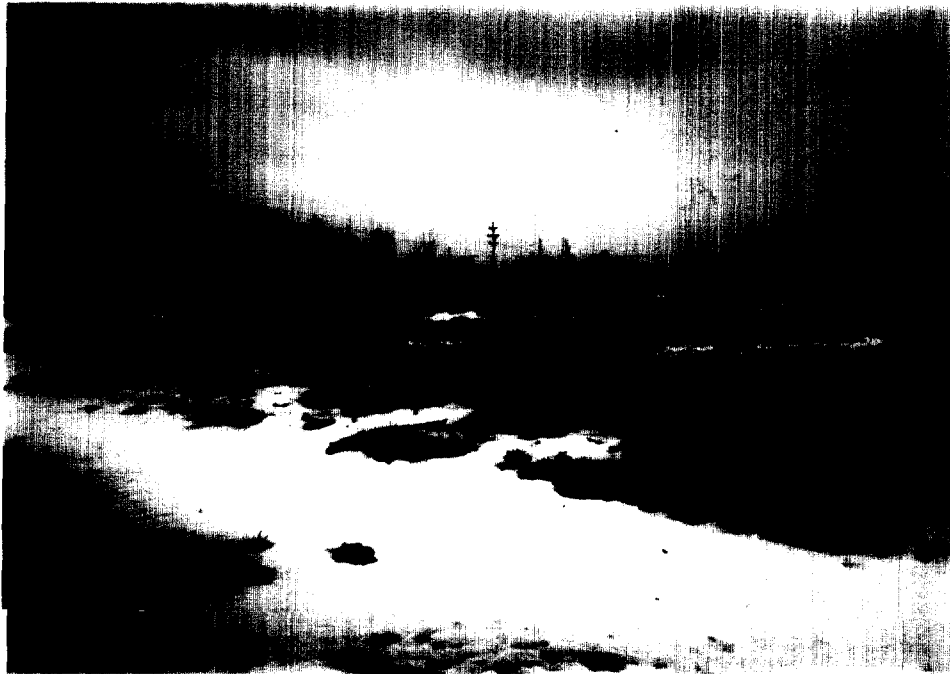
Photograph No.: 3

Description: Picture taken from the northeast corner of the landfill looking southwest towards the entrance. Piles of dirt from local construction activities are visible.

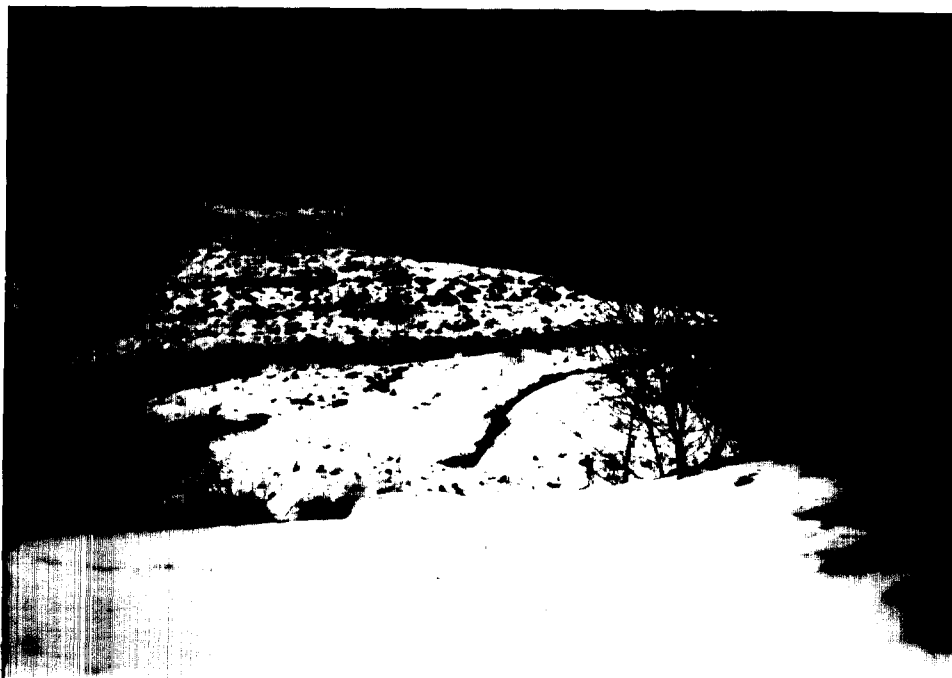
Photograph No : 4

Description: Picture taken from the northeast corner of the landfill looking north. Riprap covering the underground sewer main is visible. A leachate seep entering the Black River and a monitoring well are located in the center of picture

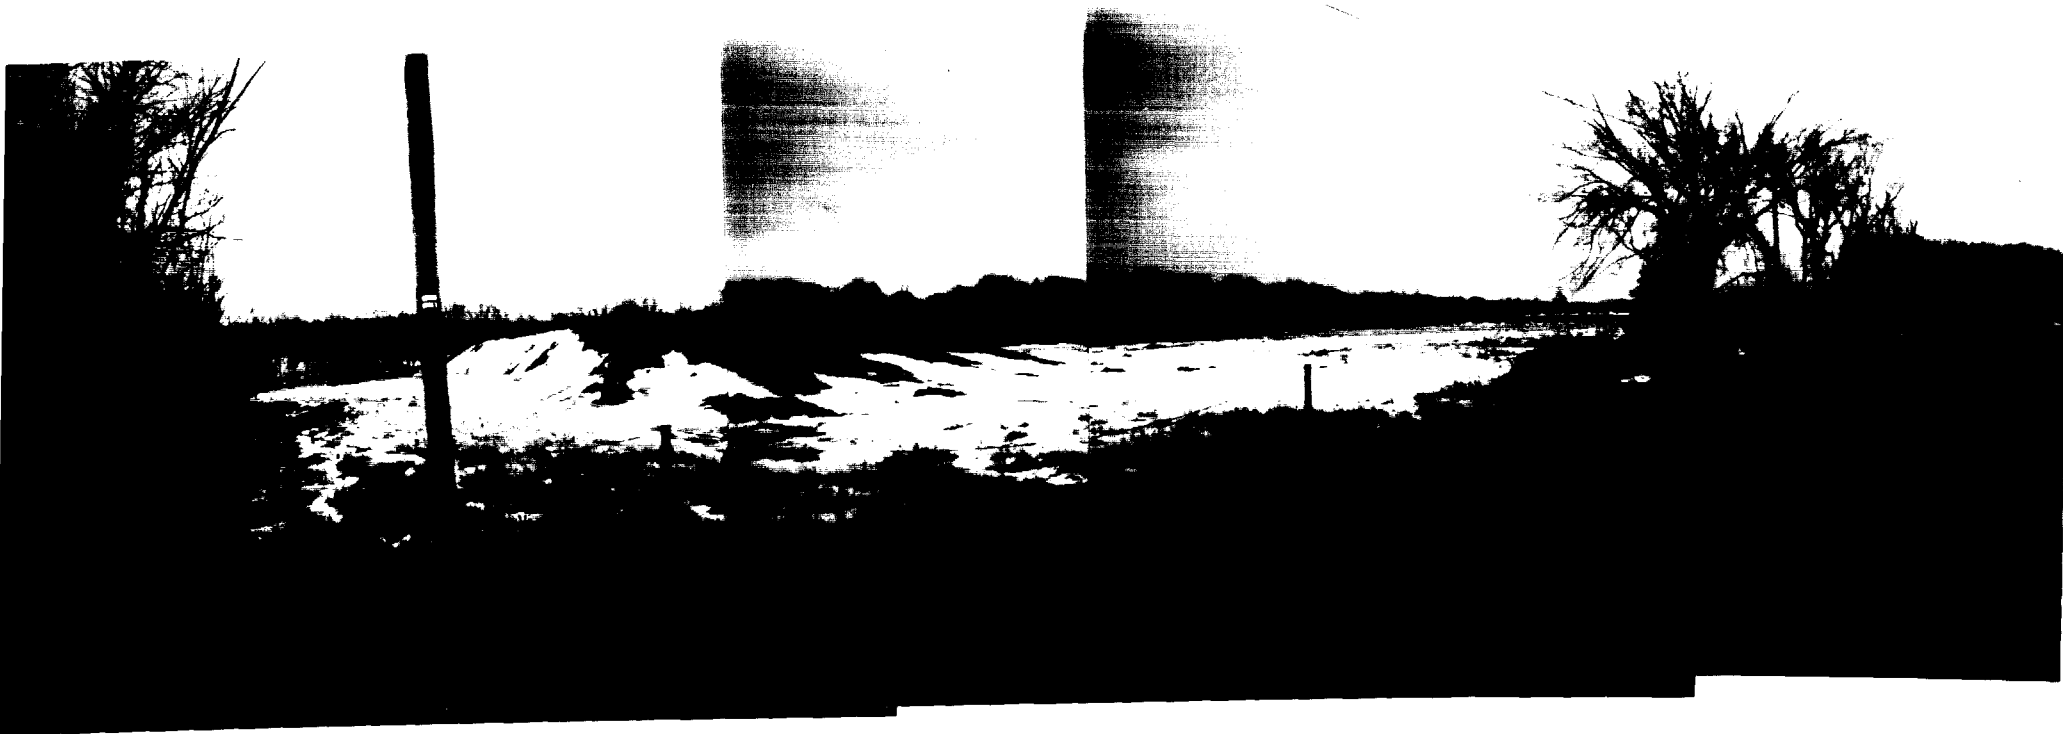
Photograph No.: 5, 6, and 7

Description: Panoramic view from northwest corner of the landfill looking east, then south along Ford Road. Piles of dirt from local construction activities are visible.

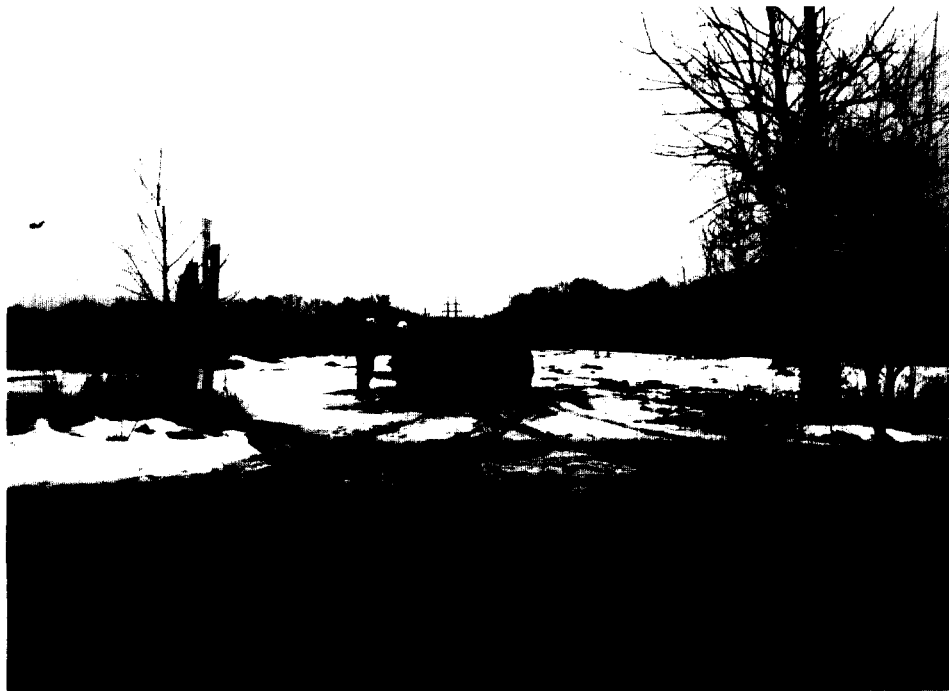
Photograph No.: 10

Description: Picture taken from Ford Road, at top of riprap, looking at the northeast corner of the landfill.

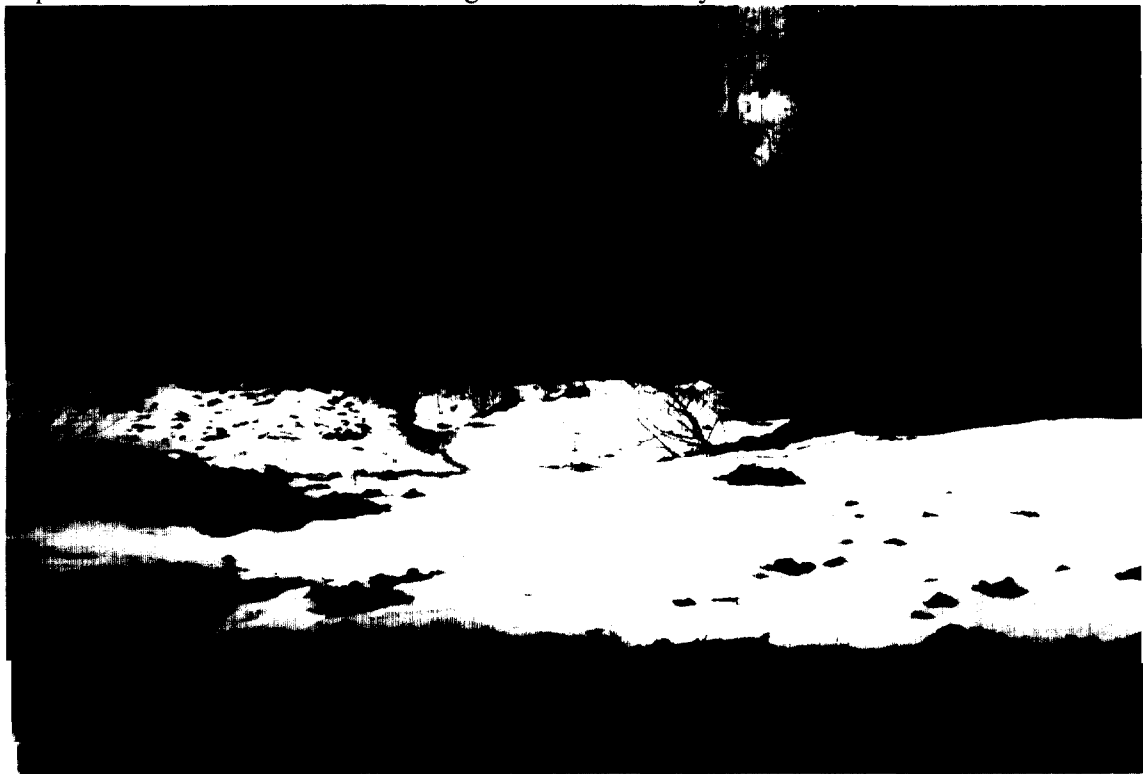
Photograph No. 2

Three monitoring wells are located along the access road parallel to the Black River. These wells were last sampled in 1979. Two wells were visible (Photograph Nos. 2 and 4), and the third well was not observed. Mr. Downey indicated that all three wells are usually visible, but the water level of the river was elevated because of recent weather conditions.

Description: View of flooding Black River and monitoring well (MW-2).

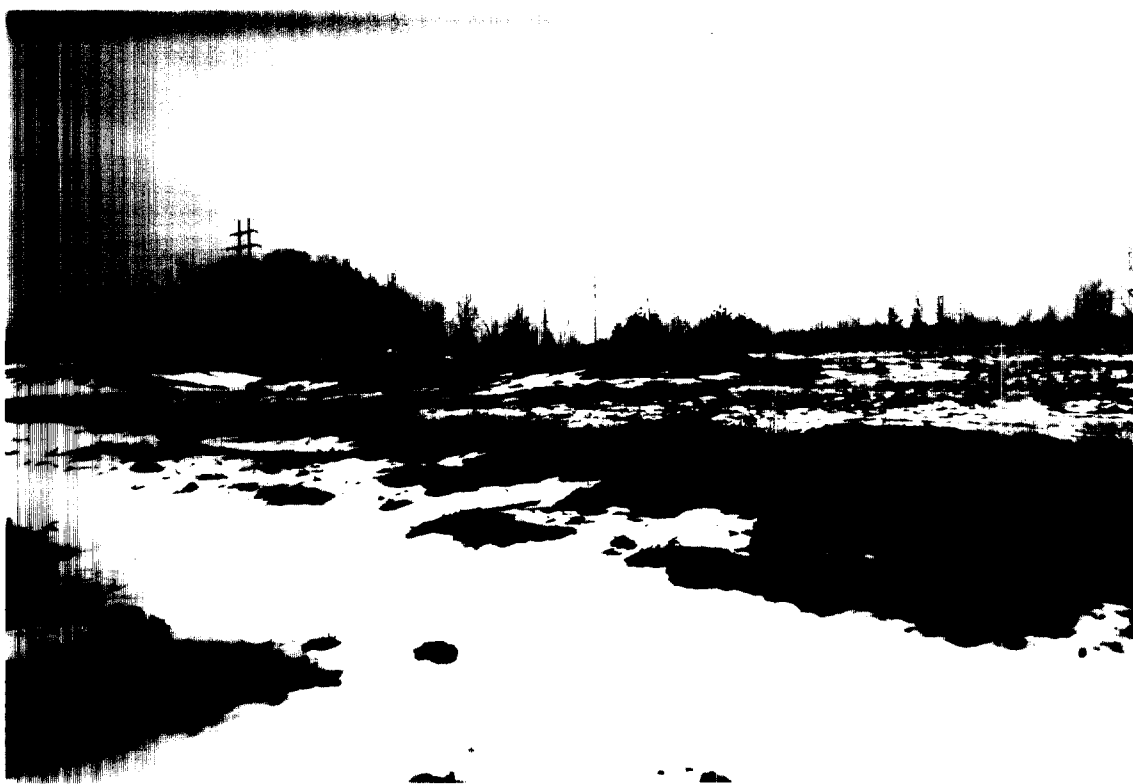
Photograph No. 3

Description: Piles of clean fill from local construction activities, used for cover.

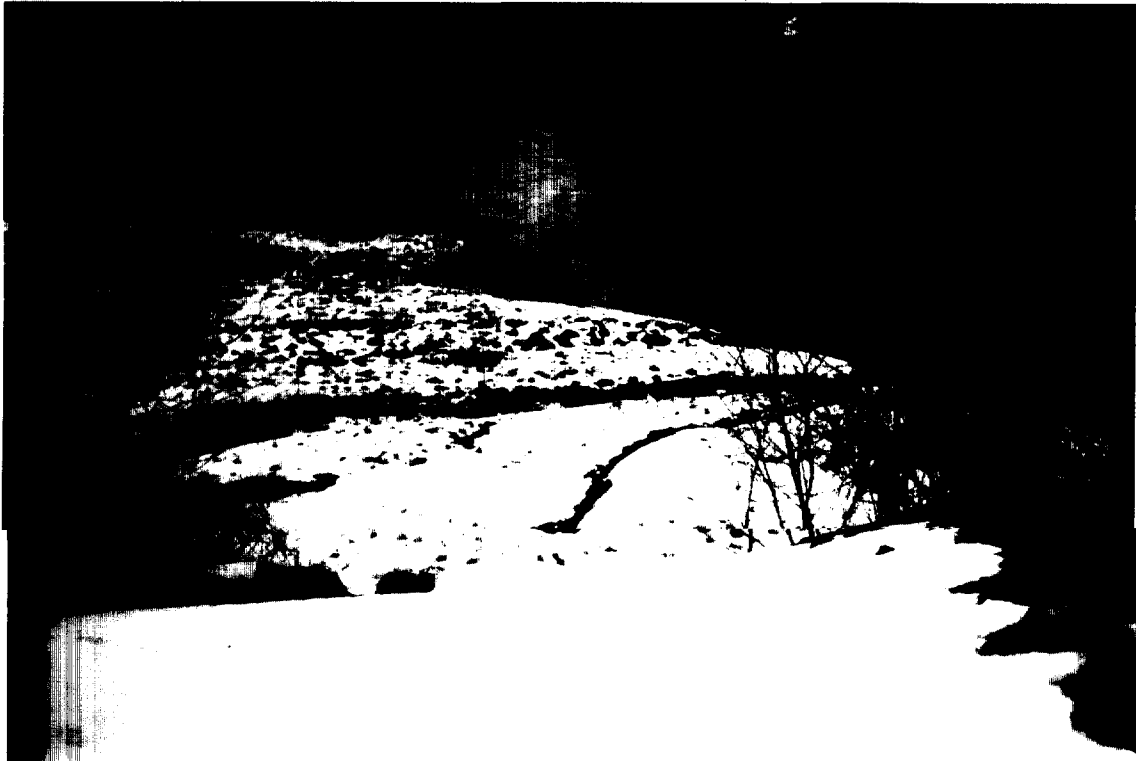
Photograph No. 4

Orange-stained sediment was observed in the intermittent stream adjacent to the north boundary of the landfill. In addition, a possible leachate seep was observed at the base of the riprap.

Description: Riprap covering the underground sewer main is visible. MW-1 and a leachate seep entering the Black River and MW-1 are located in the center of the picture

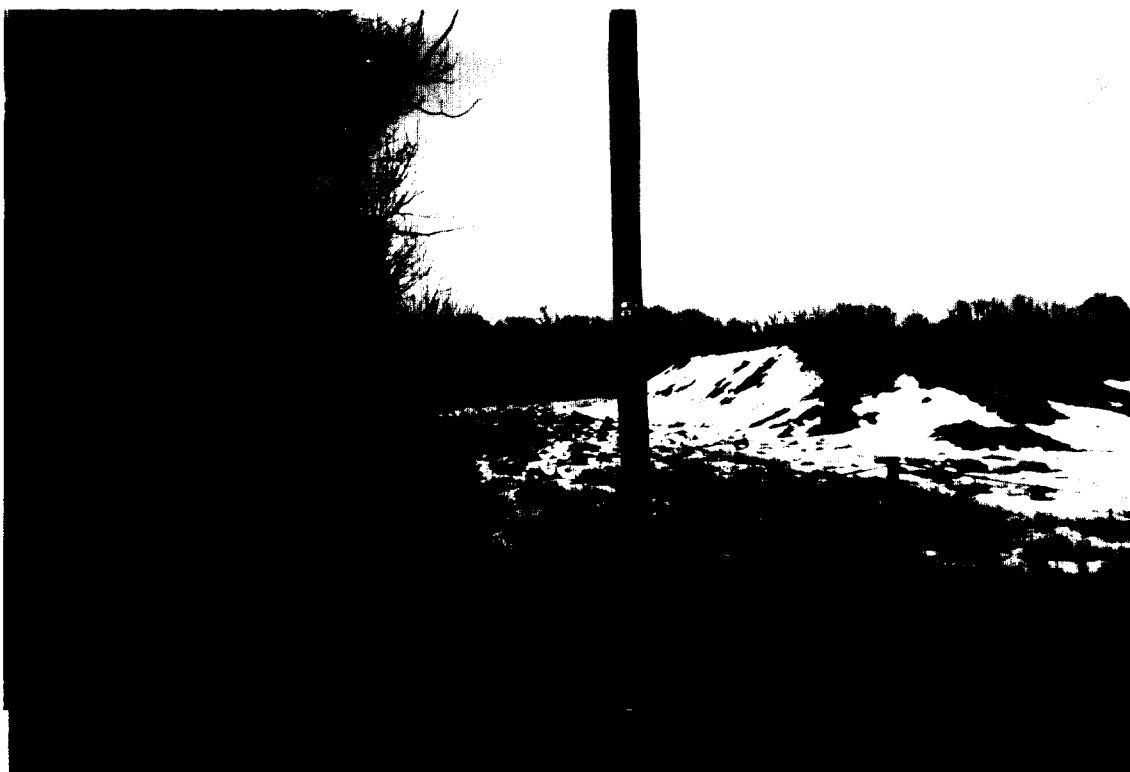
Photograph No. 5

Description: Chain barrier along Ford Road. Intermittent stream is to the left in the trees.

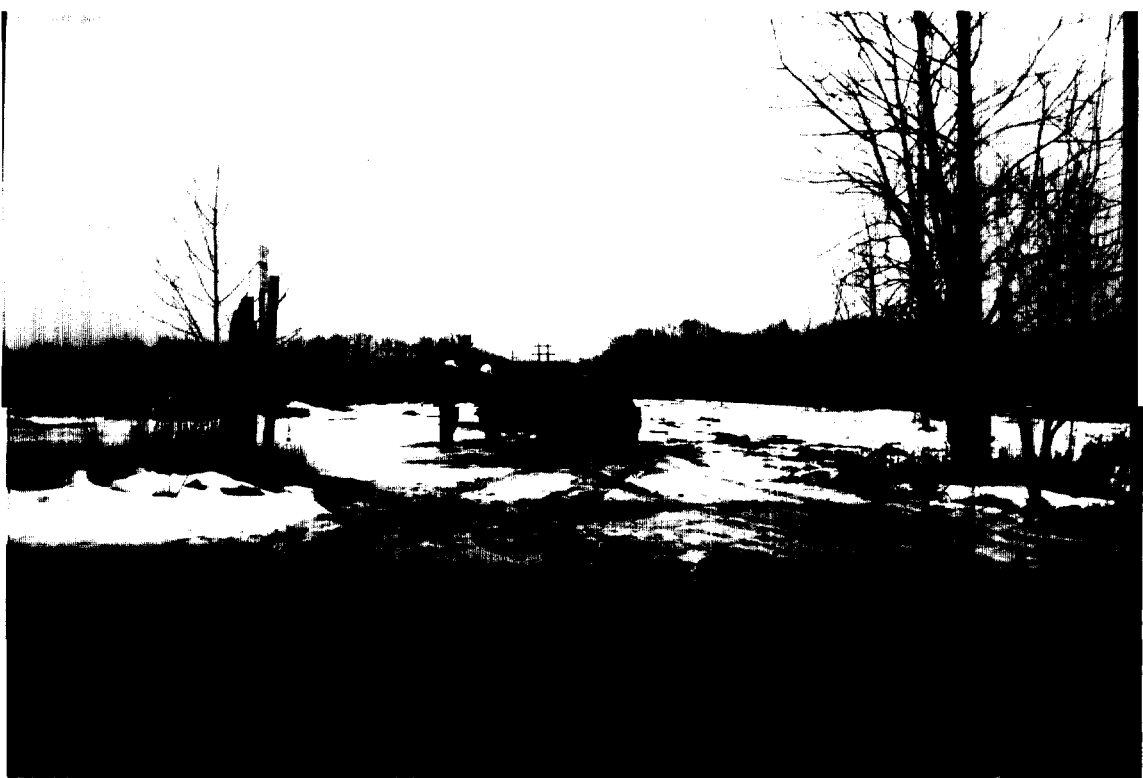
Photograph No. 10
 Orientation East
 Description Entrance to the Ford Road Landfill.

Location: Ford Road
 Date: 03/08/93

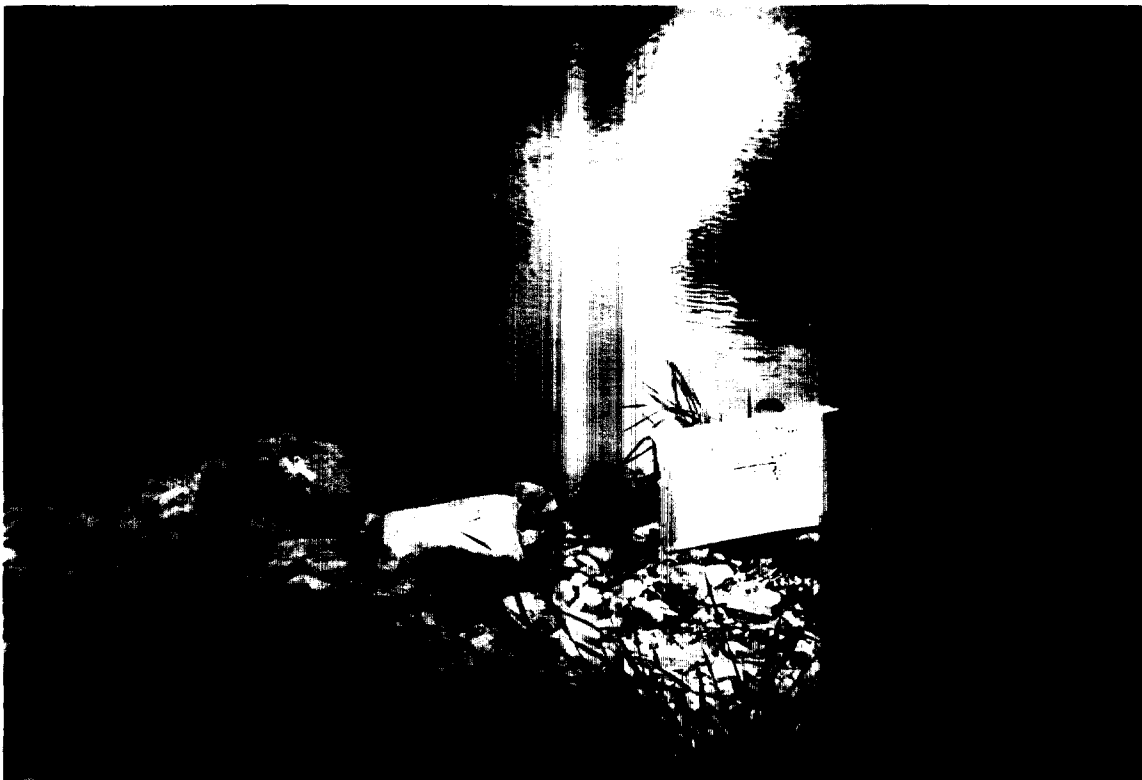
Photograph No. 25

PRC collected two surface water samples (SW-02 and SW-05) from the Black River. SW-02 was taken directly at the outfall to the Black River from the drainage pipe (Photograph No. 25). There was no discharge from the drainage pipe at the time of sampling. The Black River is approximately 75 feet wide, fast moving (in winter), and approximately 1 foot deep at this sample location. A duplicate of this sample was taken. SW-05 was designated the background sample. It was taken upstream of runoff drainage points (Photograph No. 28). This sample was designated the matrix spike-matrix spike duplicate.

Location: Black River

Description: Location of samples SD-02, SW-02, and SW-2D.

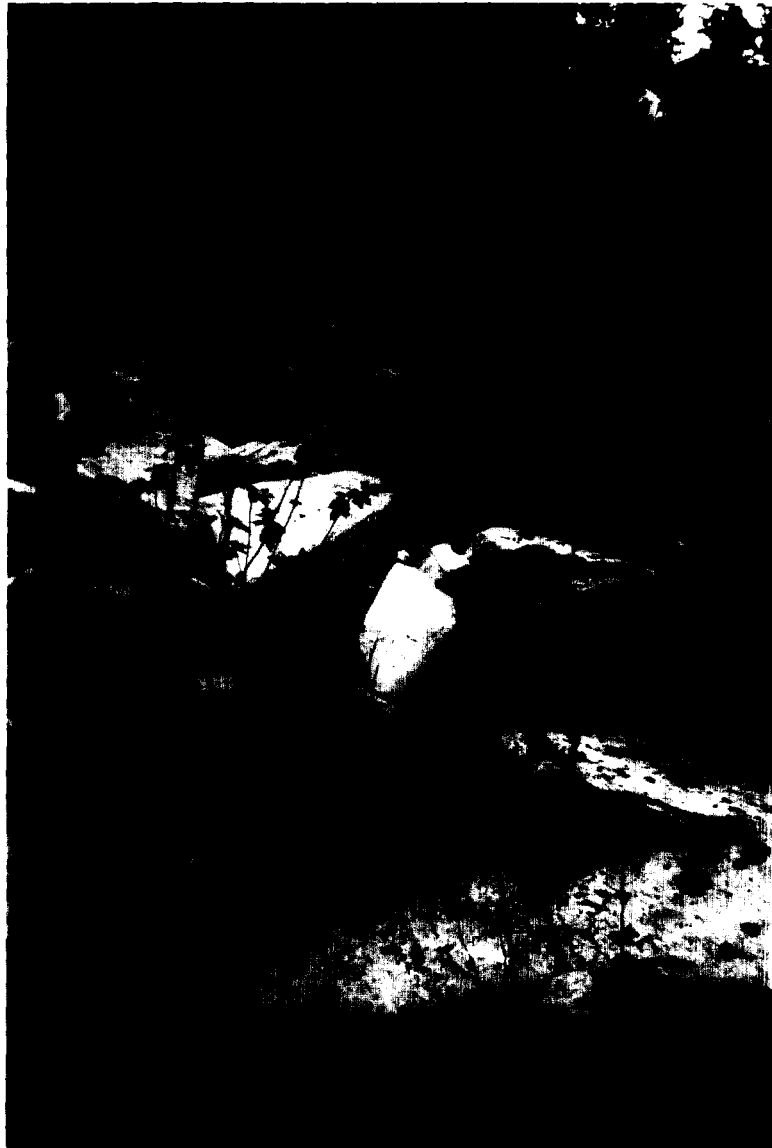
Photograph No. 32

Location: Black River
